2
The 2nd International Conference on Rehabilitation and Maintenance in Civil Engineering

Lesson Learned from 27th May 2006 Yogyakarta Earthquake - Case of Building with Long Span of Roof Structure

5
Ade Lisantono^{a*} and Yoyong Arfiadi^a

^aDepartment of Civil Engineering, Universitas Atma Jaya Yogyakarta, Indonesia

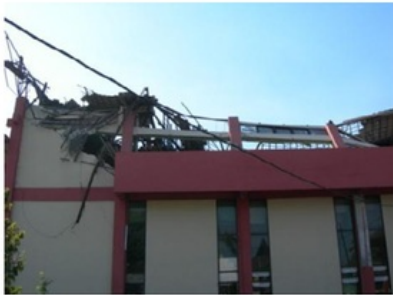
Figure 2. Among Rogo sport building.

Some of collapse of engineered buildings in Yogyakarta earthquake had long span roof structures. Figures 2, 3, and 4 show some collapse of engineered buildings which had long span of roof structures.

The collapse of engineered buildings which had long span roof structures probably due to the collapse of roof structure itself or the stiffness of the upper column is not sufficient to support the roof structure when subjected to the earthquake loading (Raharjo et al. 2007).

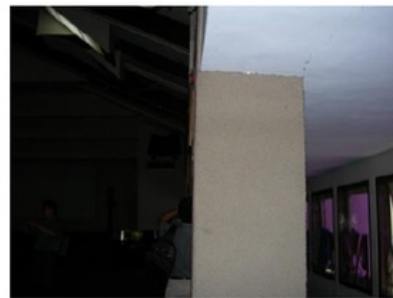
After the earthquake, some columns of the Auditorium which support the roof structures were cracks and declined (see Figure 6).

Figure 6. Columns of Auditorium were declined

Wibowo et al. (2007) stated that the failure columns in the Auditorium due to the capacity columns were not adequate to resist the combine loading including the earthquake loading. Wibowo et al. (2007) proposed two items for repairing the problem. First improving the stiffness of roof structure by adding truss elements into the original roof structure using steel shape of U 75x40x5x7 (see Figure 7).

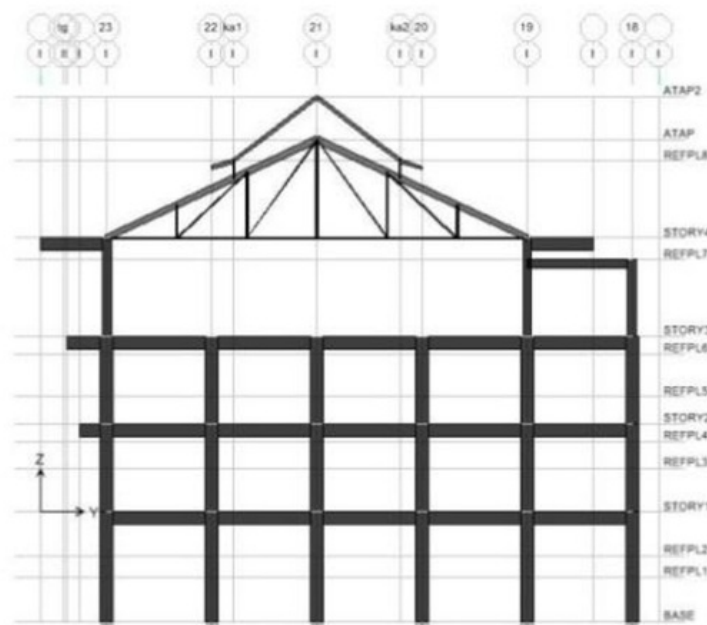
Figure 7. Modified roof structure of Auditorium (Wibowo et al. 2007)

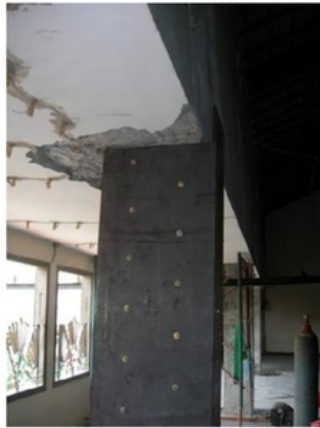
Figure 8. Jacketing method for declined column (Wibowo et al. 2007)

Second for repairing the declined columns, they proposed to repair the columns by using jacketing methods with steel structure (see Figure 8).
