## CHAPTER VI

### CONCLUSION AND RECOMMENDATION

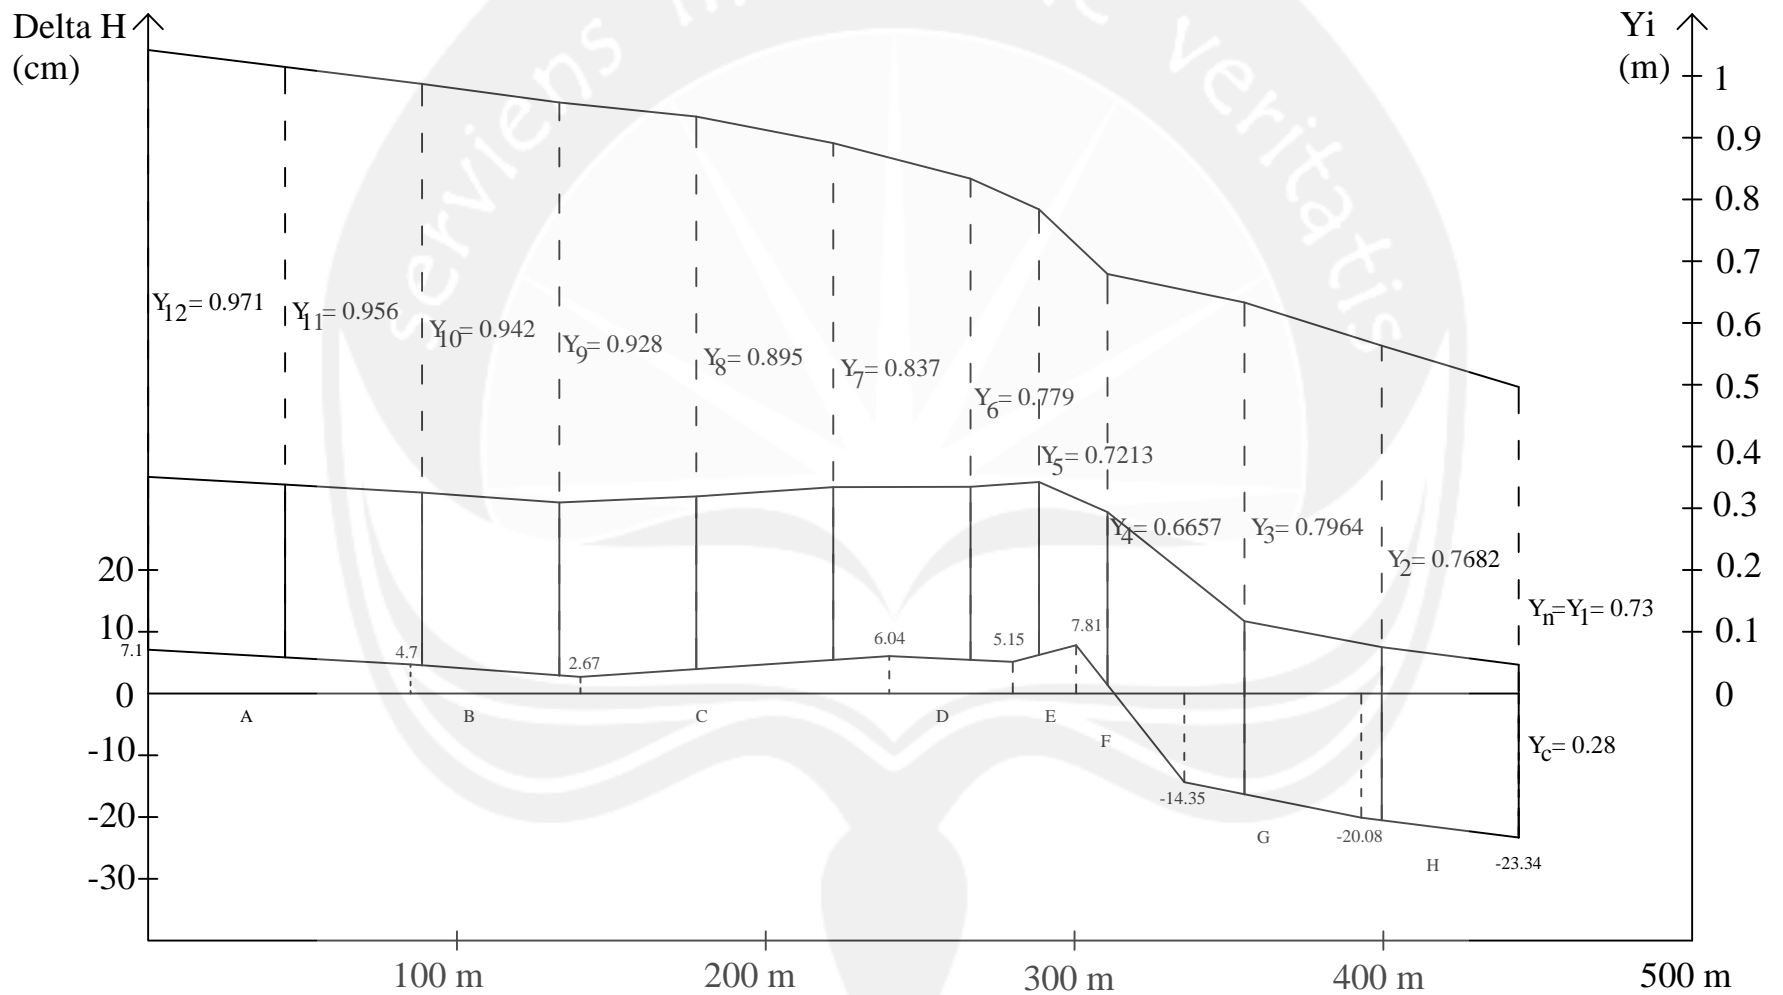
Figure 5.1. Water surface profile of Segment 11, Sentul Secondary Canal

Relating to the results of water surface profile calculation, the existing canal slope in Segment 11 of Sentul Secondary Canal is not a problem because the water is still flowing from upstream to downstream. Even if the upward slope is assumed as downward one, the water surface profile shows that the water will still flow, but the water height is lower which means the discharge will be lower. Therefore, the improper slope in Segment 11 of Sentul Secondary Canal is not the cause of problem.
