Procedia Engineering 54 (2013) 158 – 164

The 2nd International Conference on Rehabilitation and Maintenance in Civil Engineering

Lesson Learned from 27th May 2006 Yogyakarta Earthquake - Case of Building with Long Span of Roof Structure

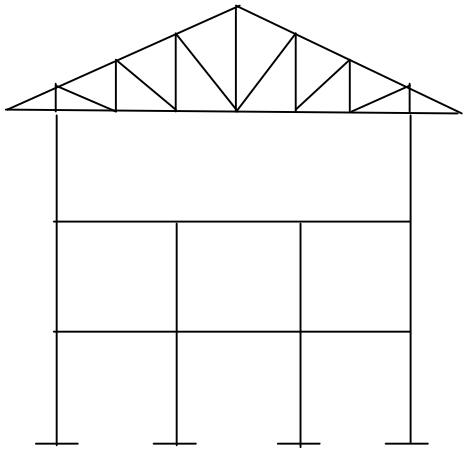
The failure of structural elements such as beams, columns, floor and roof structures can be categorized as structural failure. Generally, the meeting room or hall such as auditorium was designed on the upper floor below the roof structure. This design made the roof structure has a long span as shown in the Figure 1.

Figure 1. Long span roof structure.

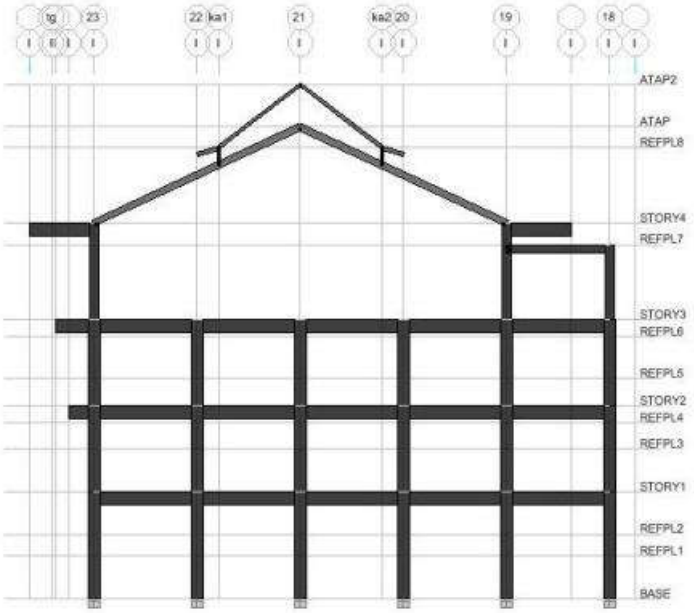
The area of Auditorium is 898.56 m^2 or (46.8 meter x 19.2 meter). There are no column in the middle of space of Auditorium, so the column only at the edge of the Auditorium. Therefore, the span of the roof structure was 19.2 meter. The original roof structure of the Auditorium before earthquake is shown in the Figure 5. The roof structure was made of steel structure and used Wide Flange steel shape (IWF300x150x6.5x9).

Figure 5. Originally roof structure of Auditorium.

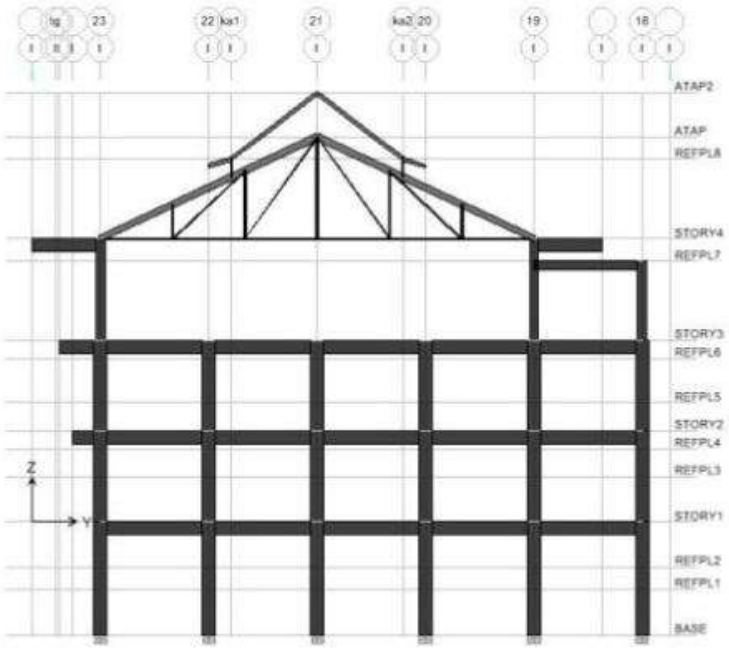
Wibowo et al. (2007) stated that the failure columns in the Auditorium due to the capacity columns were not adequate to resist the combine loading including the earthquake loading. Wibowo et al. (2007) proposed two items for repairing the problem. First improving the stiffness of roof structure by adding truss elements into the original roof structure using steel shape of U 75x40x5x7 (see Figure 7).

Figure 7. Modified roof structure of Auditorium (Wibowo et al. 2007)

By adding stiffness of the roof structures and repairing the declined columns, now the roof structures and columns of the Auditorium of St. Thomas Aquinas Building of Universitas Atma Jaya Yogyakarta become adequate and stable to resist combine loading including the earthquake loading.
