2
The 2nd International Conference on Rehabilitation and Maintenance in Civil Engineering

Lesson Learned from 27th May 2006 Yogyakarta Earthquake - Case of Building with Long Span of Roof Structure

5
Ade Lisantono^{a*} and Yoyong Arfiadi^a

^aDepartment of Civil Engineering, Universitas Atma Jaya Yogyakarta, Indonesia

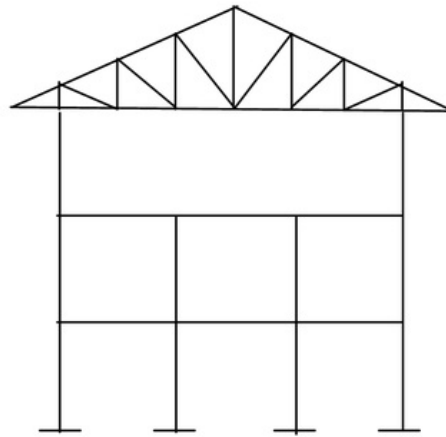
Figure 1. Long span roof structure.

The failure of structural elements such as beams, columns, floor and roof structures can be categorized as structural failure. Generally, the meeting room or hall such as auditorium was designed on the upper floor below the roof structure. This design made the roof structure has a long span as shown in the Figure 1.

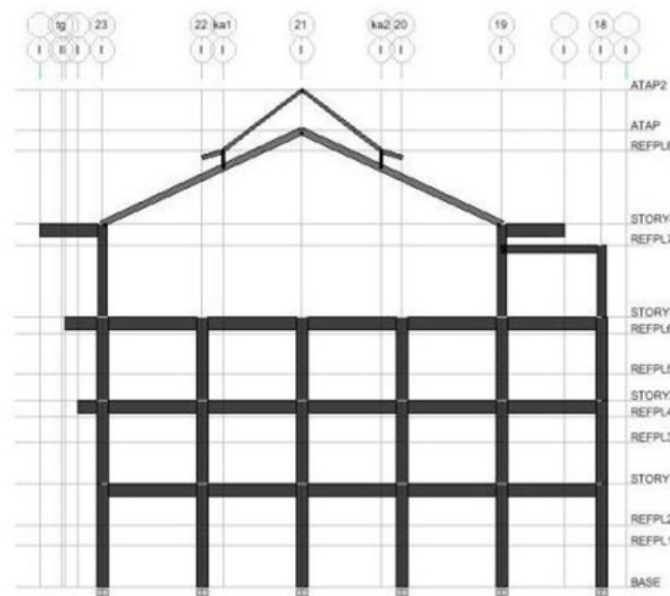
Figure 5. Originally roof structure of Auditorium.

The area of Auditorium is 898.56 m^2 or (46.8 meter x 19.2 meter). There are no column in the middle of space of Auditorium, so the column only at the edge of the Auditorium. Therefore, the span of the roof structure was 19.2 meter. The original roof structure of the Auditorium before earthquake is shown in the Figure 5. The roof structure was made of steel structure and used Wide Flange steel shape (IWF300x150x6.5x9).

Wibowo et al. (2007) stated that the failure columns in the Auditorium due to the capacity columns were not adequate to resist the combine loading including the earthquake loading. Wibowo et al. (2007) proposed two items for repairing the problem. First improving the stiffness of roof structure by adding truss elements into the original roof structure using steel shape of U 75x40x5x7 (see Figure 7).
