## BAB 6

### KESIMPULAN

**LAMPIRAN 1**  
**LEMBAR INSPEKSI JEMBATAN**  
**KARANGGAYAM**

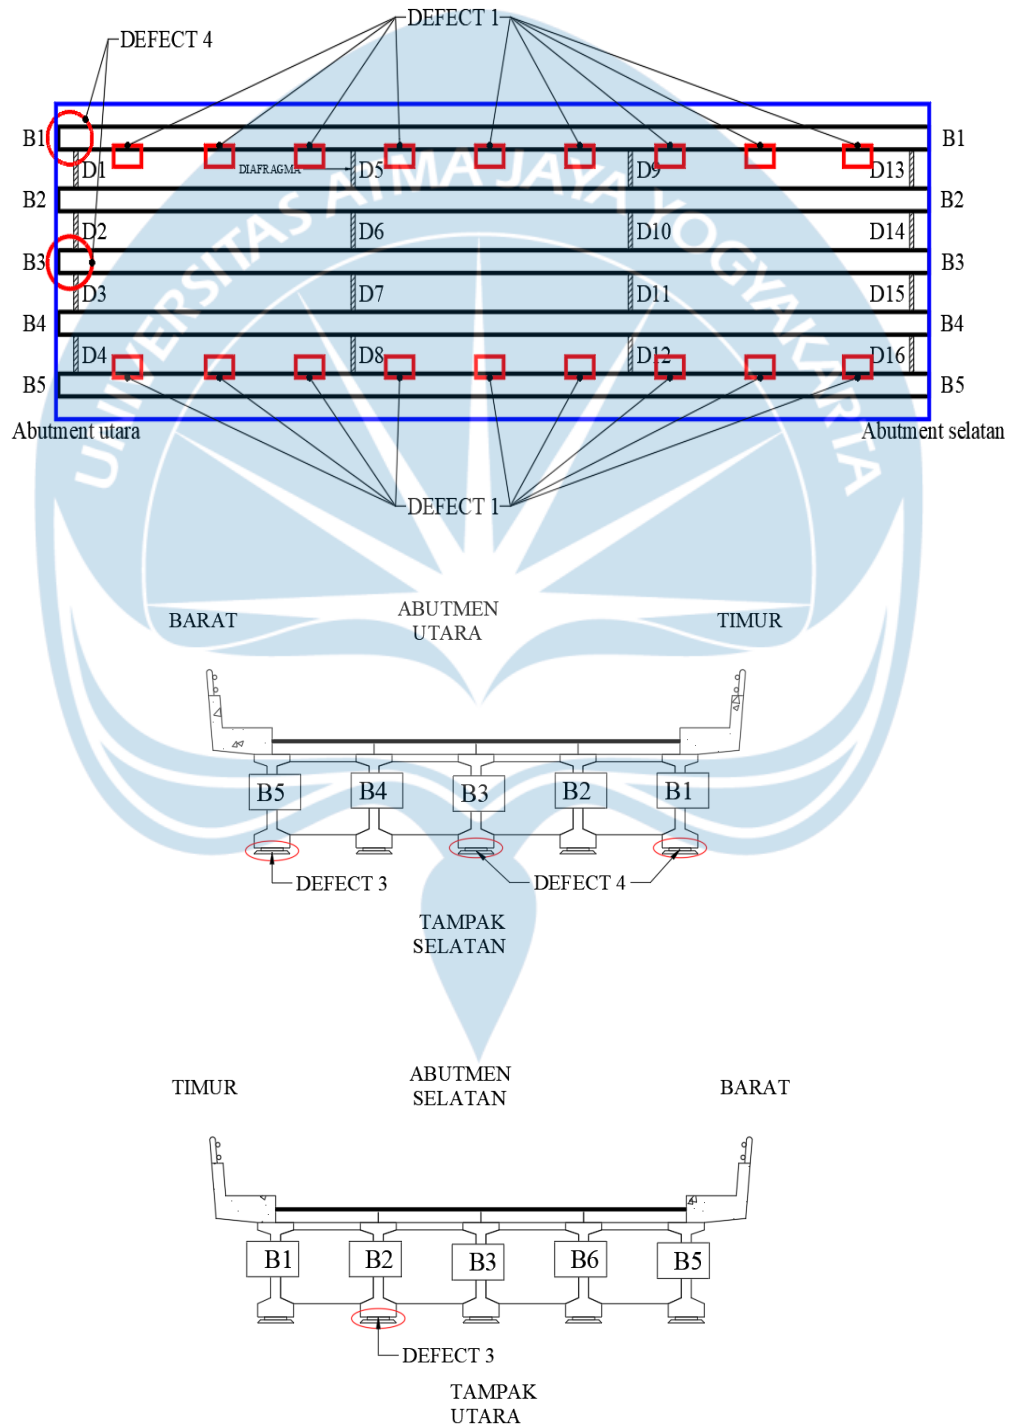
# Defect Mapping Sheet

Bridge Name	Karanggayam	Latitude	-7.8468
Road Name	Sampakan - Singosaren	Longitude	110.4399
Crossing/General Location	Sungai Opak		
Region	Bantul, DIY		
Inspector	Y. Aryo Pramudito		
Date	Wednesday, June 28, 2023

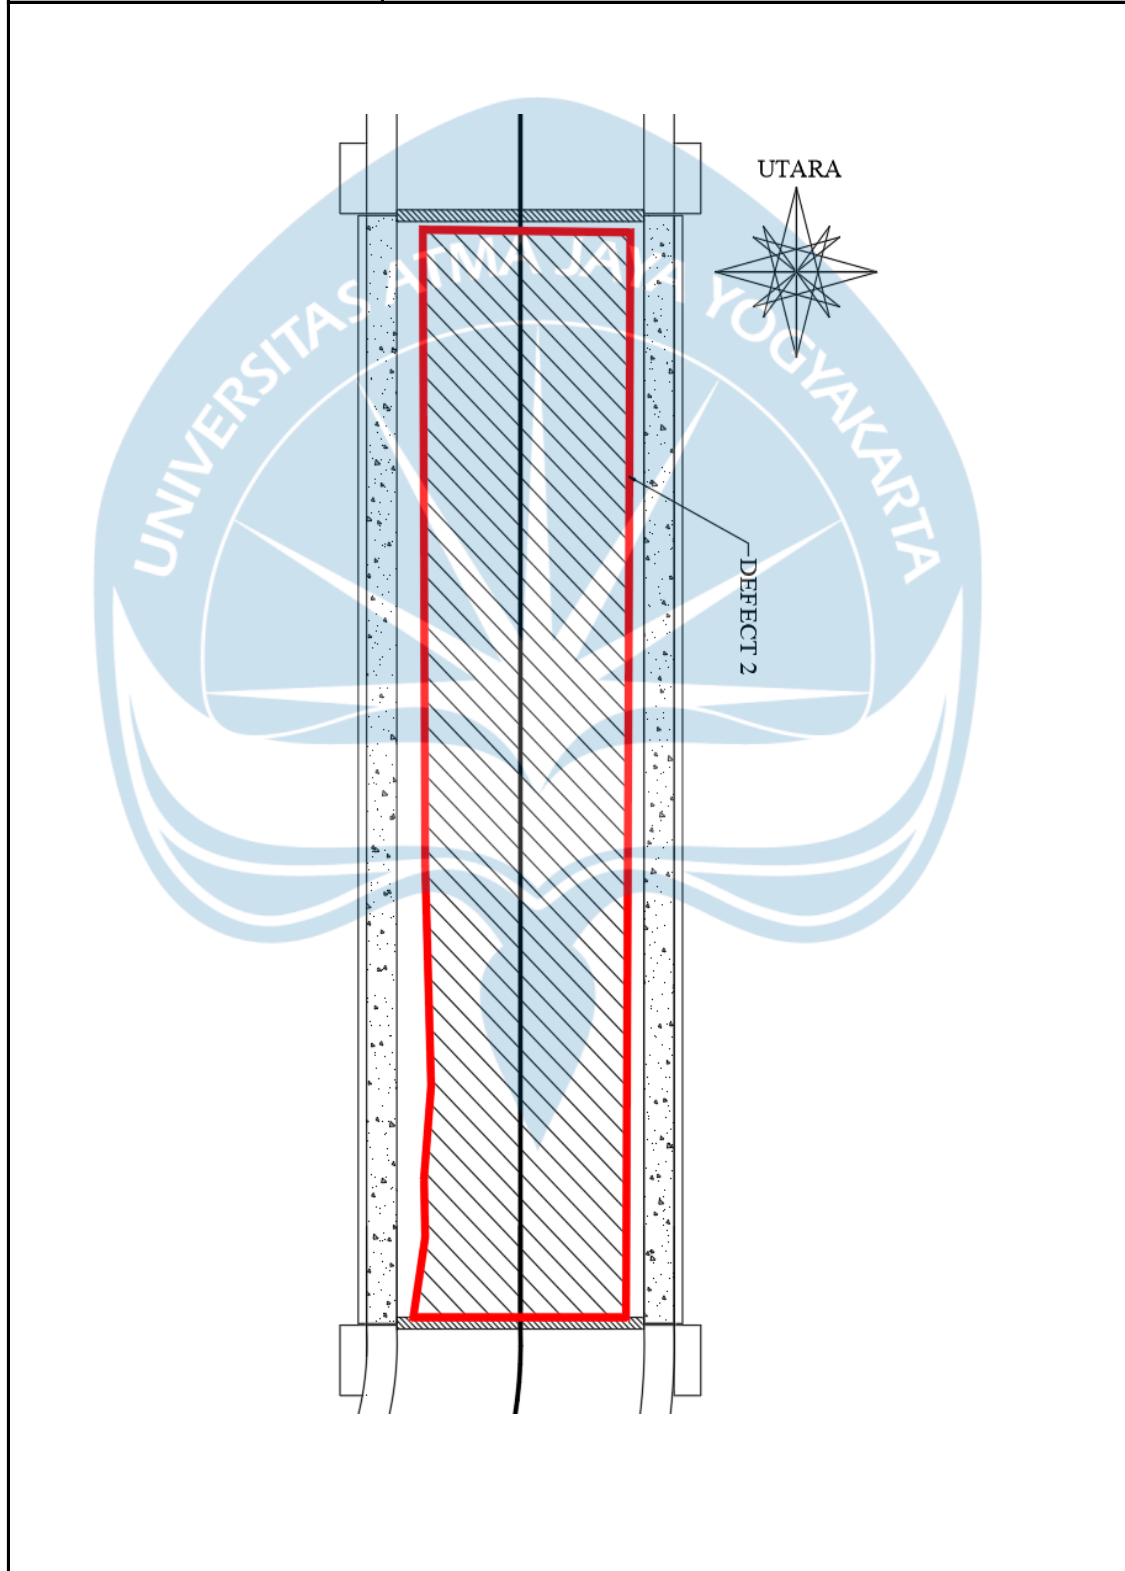
## Defect Mapping Sheet

Bridge Name	Karanggayam	Latitude	-7.8468
Road Name	Sampakan - Singosaren	Longitude	110.4399
Crossing/General Location	Sungai Opak		
Region	Bantul, DIY		
Inspector	Y. Aryo Pramudito		
Date	Wednesday, June 28, 2023

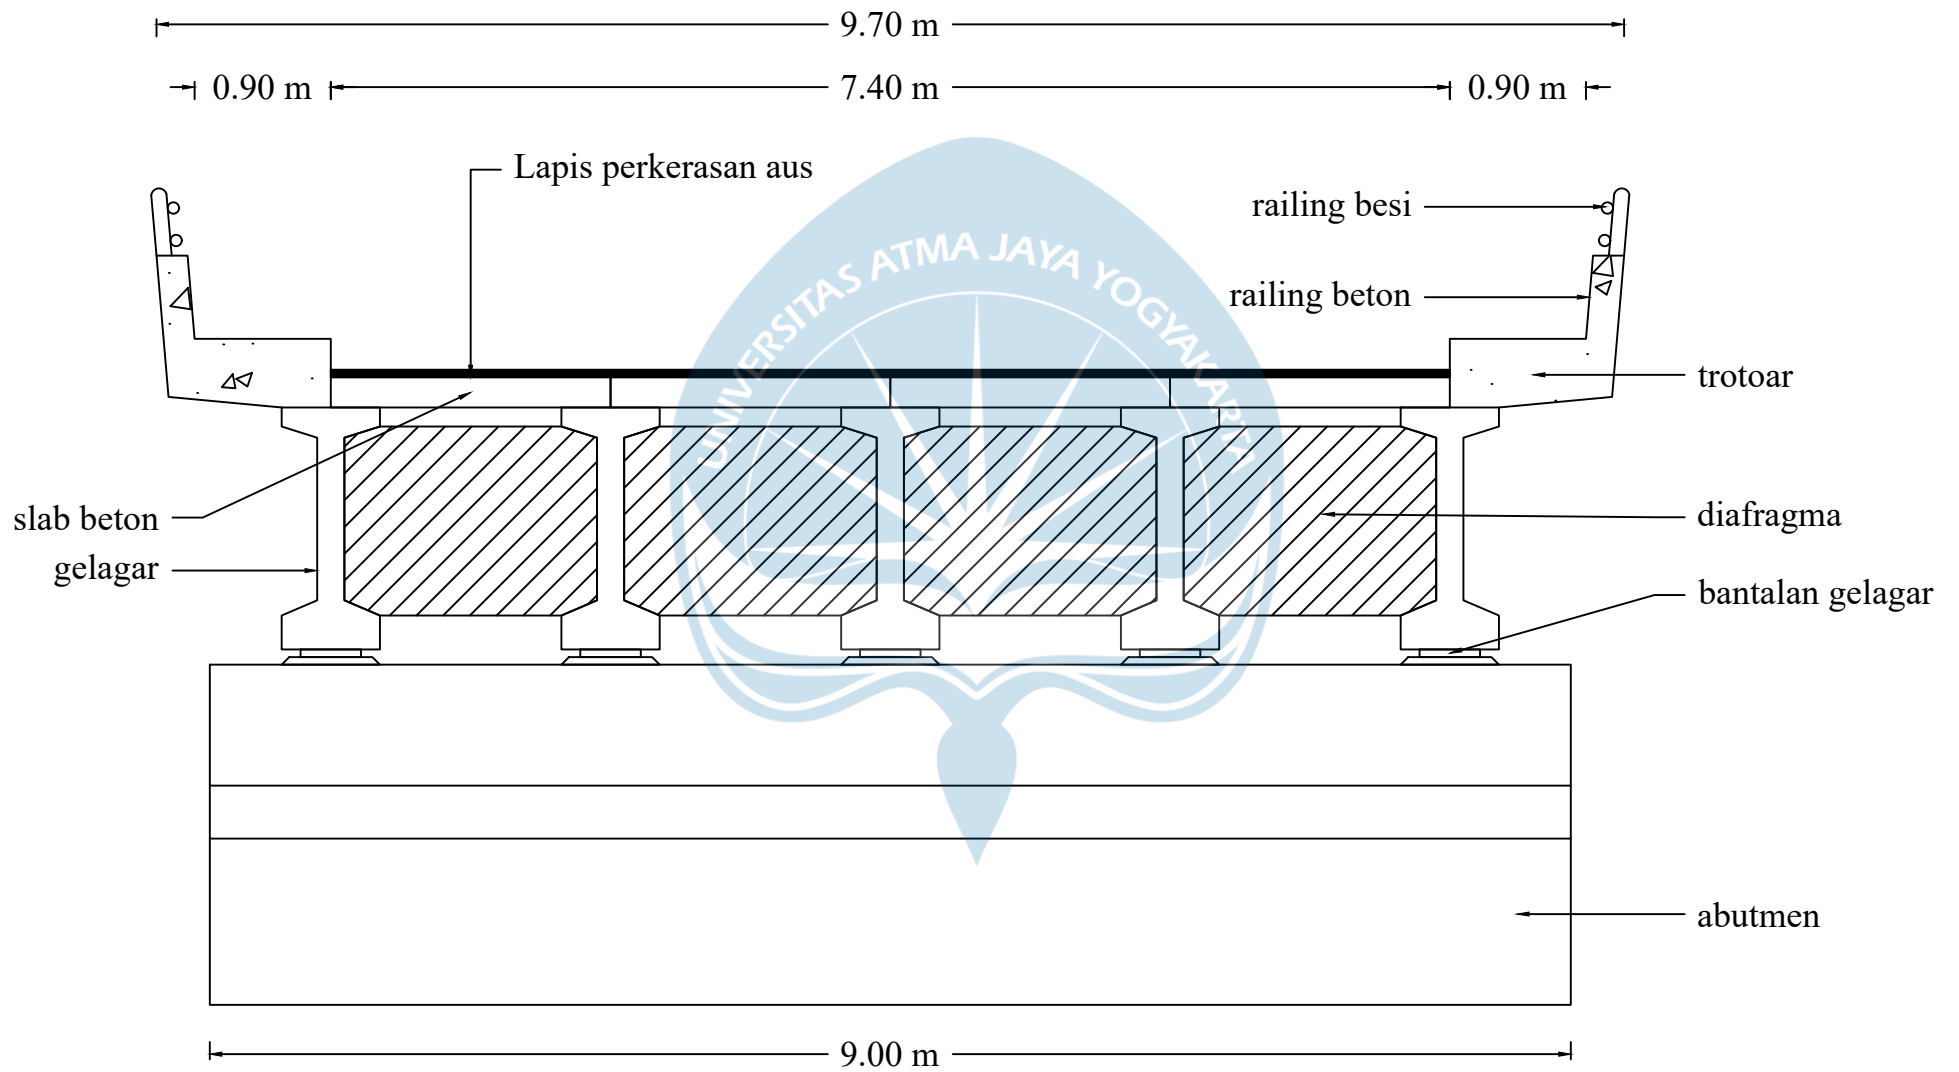
Bridge Name	: Karanggayam I	Drawing Title	Scale
Road Name	: Sampakan Singosaren		1:200
Crossing/General Location	: Sungai	TAMPAK SAMPING	Sheet No.
Region	: Bantul, DIY		02

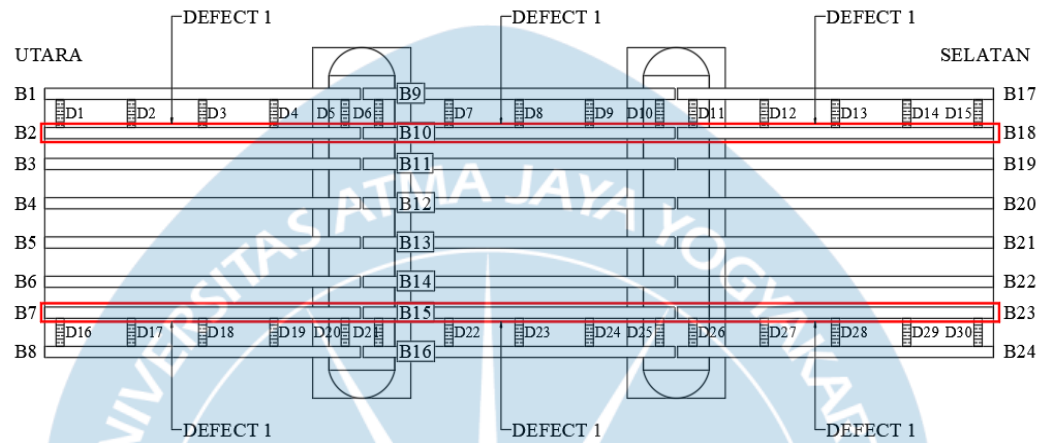
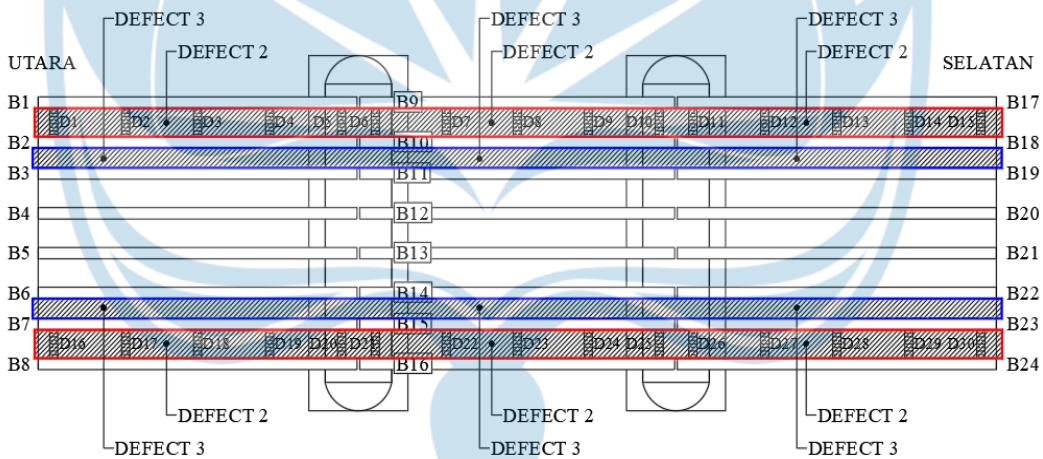
# Defect Mapping Sheet

Bridge Name	Ngalang	Latitude	-7.8854
LAMPIRAN 3	Sambipitu - Nglipar	Longitude	110.5746
LEMBAR INSPEKSI JEM	Sungai Ngalang		
Region	Gunungkidul, DIY		
Inspector	Y. Aryo Pramudito		
Date	Sunday, March 5, 2023

- b. Jembatan Ngalang: (1). lantai jembatan seluas 98,84 m<sup>2</sup> mengalami kehilangan bagian beton, pengkristalan dan korosi pada tulangan yang termasuk dalam nilai kondisi 3. (2). Sambungan lantai jembatan antara span 1 dan span 2 mengalami retakan dan pergeseran.

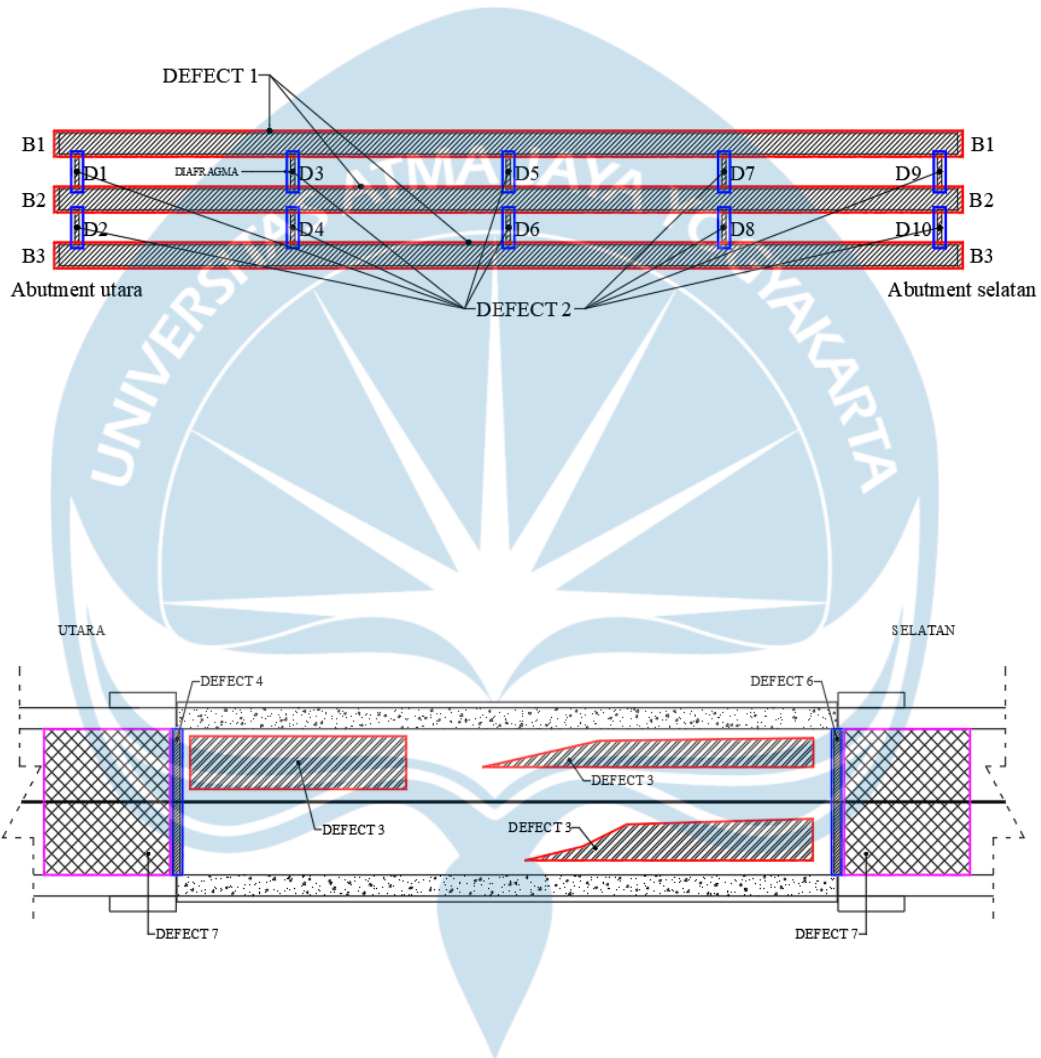
# Defect Mapping Sheet

Bridge Name	Jlantir	Latitude	-7.9313
Road Name	Karangmojo - Semin	Longitude	110.6851
Crossing/General Location	Sungai Ngalang		
Region	Gunungkidul, DIY		
Inspector	Y. Aryo Pramudito		
Date	Saturday, June 3, 2023

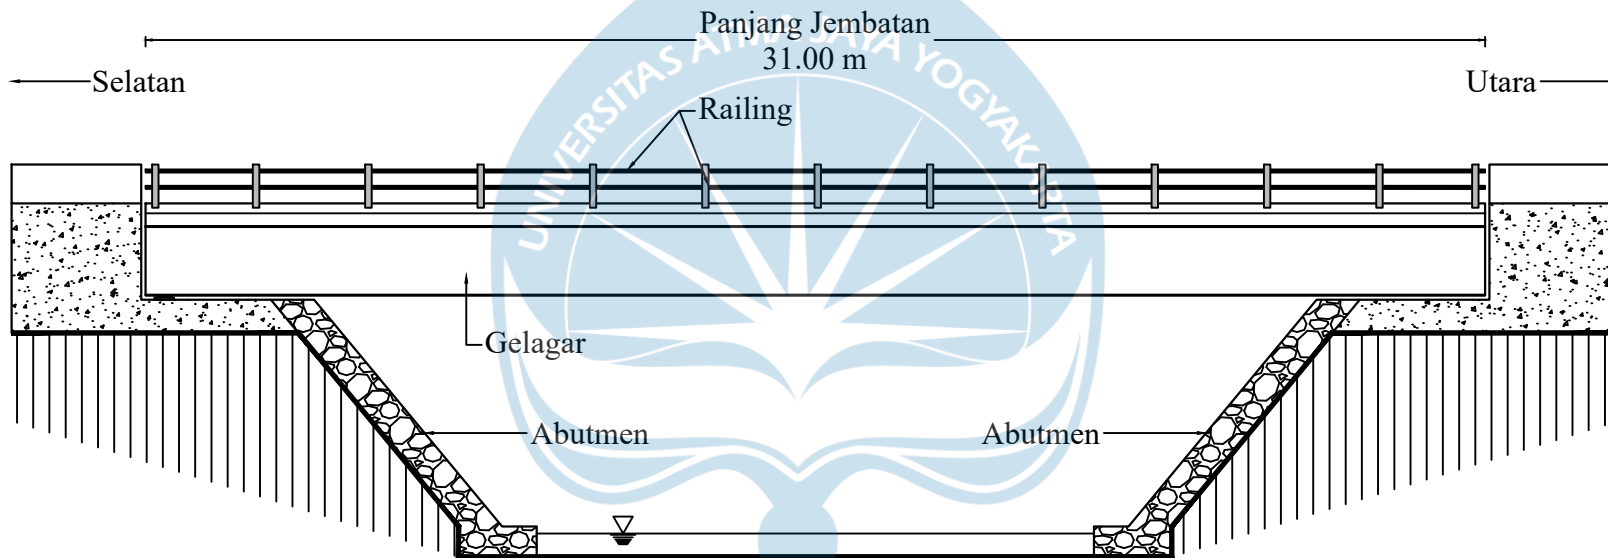
Bridge Name	: Klepu	Drawing Title	Scale
Road Name	: Dekso - Klangon		1:175
Crossing/General Location	: Sungai		Sheet No.
Region	: Kulon Progo, DIY		02
