CHAPTER I

INTRODUCTION

1.1. Background

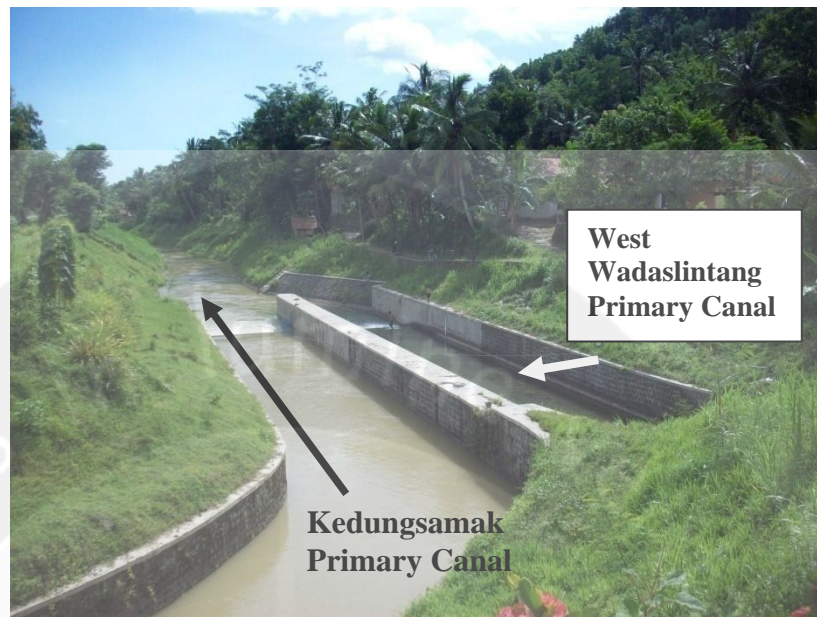
Figure 1.3. Kedungsamak and West Wadaslintang Primary Canal

The Sentul Secondary Canal is the longest one in Kedungsamak. Kedungsamak Weir irrigates 6,758 ha (Group I is 1,918 ha; Group II is 2,694 ha; and Group III is 2,146 ha). Those groups rotate annually. The S.15 Ka and S.16 Ka fields are included in Group I as shown in Figure 1.2. The water is taken from Luk Ulo River and West Wadaslintang Primary Canal flows the water to supply additional (*suplesi*) water to Kedungsamak Primary Canal.

The S.15 Ka (166 ha) and S.16 Ka (157 ha) fields are located in Siti Adi Village, Purwoharjo Village, and Tukung Gedong Village in Puring Sub-district (Figure 1.2). They are part of service area of Kedungsamak Primary Canal precisely at the end of Sentul Secondary Canal (Figure 1.3).

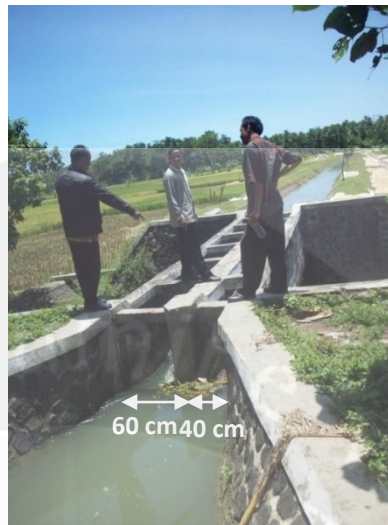
Figure 1.5. Flume 11c

2. Flume 11c in Segment (RS) 11 initially had 60 cm width. Since it was considered too small then rehabilitation work was done. An additional 40 cm width flume was built next to the previous one without demolishing the old one because of lack of fund (Figure 1.5). Consequently, leakages happen at some places in the upstream and downstream ends because the bond between the canal lining (stone masonry) and the old flume (concrete) is deteriorating due to their age. Therefore, water is wasted to the Rama Drainage Canal that flows under the flume.
